## **ATVs and Water Bar Hazards**

Location: Inactive Resource Roads throughout British Columbia

Date: August 2020

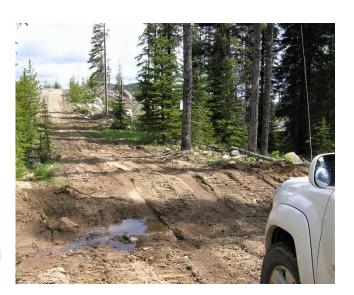
At the bottom of a hill the ATV struck a water bar that was not visible until the operator was upon it. The impact caused the machine to jump and, although the operator managed to keep the ATV upright, he seriously jarred his back and wrist. Had the ATV overturned the outcome could have been significantly more severe.

- Do not become complacent when riding an ATV/UTV and always expect the unexpected, especially when riding on an unfamiliar road
- Ride the ATV/UTV at a safe speed for the road if unfamiliar with the road keep your speed to a minimum
- Use proper PPE when riding and ATV/UTV
- Employ the principles of <u>RADAR</u> when riding.
