# SAFETY ALERT

## Lowboy / Lowbed incidents lead to serious operator injuries

**Location:** U.S. Pacific Northwest

**Date of Incidents:** 2019

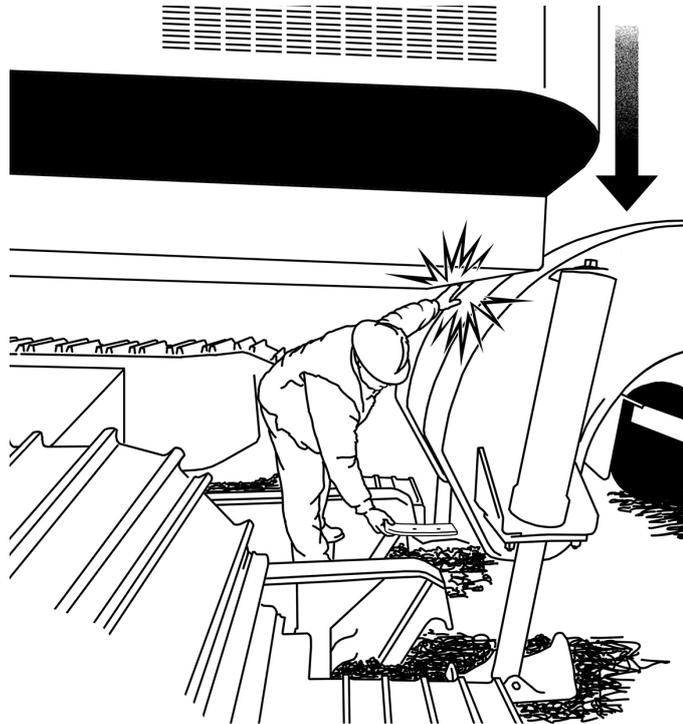
**Details of Incident 1:** A lowboy operator was coupling the lowboy gooseneck to a lowbed trailer deck after loading and chaining down a processor. During coupling, the hooks of the trailer did not fully couple over the steel pins of the gooseneck. It can be difficult to determine when this happens, as there is no good way to visually inspect the connections of the components.

After backing in the lowboy, the operator climbed under the machine counterbalance to place shims. The operator can only place shims by climbing in between the gooseneck and the trailer after the initial hookup is completed. The shims are stored on a keeper post on the rear of the gooseneck. He reached under the machine counterbalance to replace the cotter pin in the keeper post.

- While the operator had prior experience, it had been over ten years since he had last worked with a lowboy. The employer assumed that because the operator had experience, he did not need training.

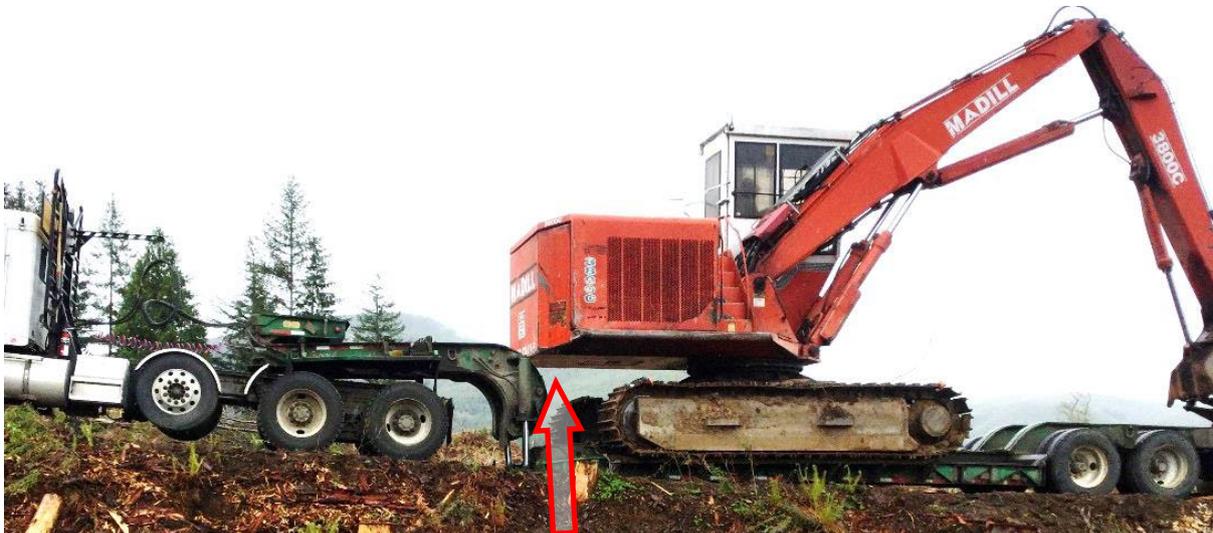
As the operator reached under the machine, he steadied himself with his left hand on the support frame of the gooseneck. At this point, the trailer detached from the gooseneck and fell to the ground. The operator's left middle finger and ring finger were crushed between the processor counterbalance and trailer gooseneck, partially amputating them.

Incident scene showing the position of the operator when the trailer detached from the gooseneck.

- Employers must adequately train employees to recognize safety and health hazards associated with the employee's specific tasks and verify that employees can safely operate new equipment and complete assigned tasks.
- Create a reference point on the trailer deck, by either painting or welding, to show when the trailer is all the way backed into the pins, ensuring proper coupling.
- Wait to position and chain down a load on the trailer until after coupling is complete. In this case, for coupling, the processor should have been positioned to the rear of the trailer deck rather than towards the front. After coupling was complete, the processor should have been repositioned forward and chained down.

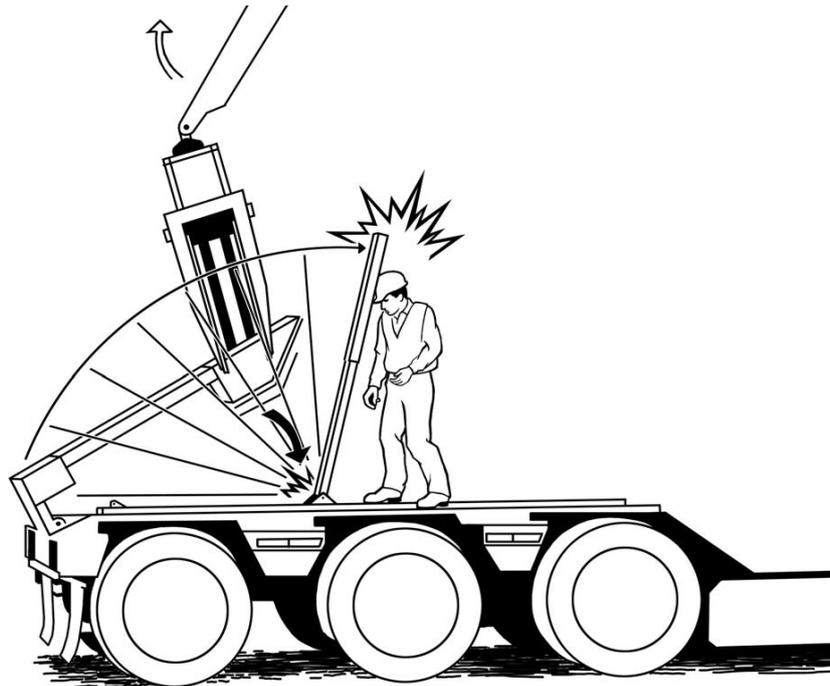
**Details of Incident 2:** A lowboy operator and a shovel operator were positioning a boom stand on a lowboy trailer in preparation for loading a shovel. The lowboy operator was standing on the trailer's deck near the rear tires as the shovel operator positioned the boom stand. He was leaning forward and reaching toward the support arm when the grapples slipped off the boom stand. As the boom stand fell towards the deck, it caused the support arm to strike the pin boss. The support arm flipped up and struck the lowboy operator's hardhat, causing him a serious head injury.

- Both the lowboy and shovel operators had prior experience in moving procedures.
- Their employer had an established procedure for lifting or lowering the boom stand using a chain attached to the grapples of a shovel. Instead, the lowboy operator directed the shovel operator to use the shovel's grapples to lift the boom stand into place.
- Make sure everyone involved understands, communicates, and follows all safety procedures in place for the tasks that they will be performing.
- Employee work areas must be spaced, and employee duties organized, so the actions of one employee do not create a hazard for any other employee.
